Trouble-Shooting Plan

Danger of Accident on Semi-conductor Ignition Systems

VDT-I-227/102 B

EFFECTS OF ELECTRICAL AND ELECTRONIC
SYSTEMS ON HEART PACEMAKERS

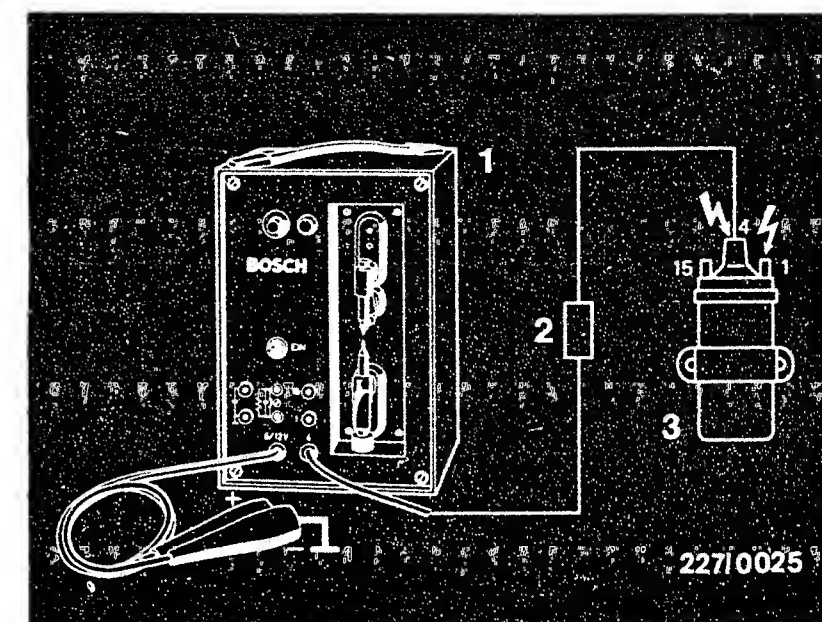
- In order to prevent the trigger box from being irreparably damaged, when using a spark gap, an interference-suppression resistor of at least 2 kΩ must be connected between the spark gap and ignition coil terminal 4, e.g. sleeve-type suppressor (5 kΩ) 0 356 500 001.
- In the case of ignition distributors with engine-speed limitation the ignition distributor side terminal 4 must have 1 kΩ interference suppression.
Operation without interference suppression will lead to the destruction of the trigger box.

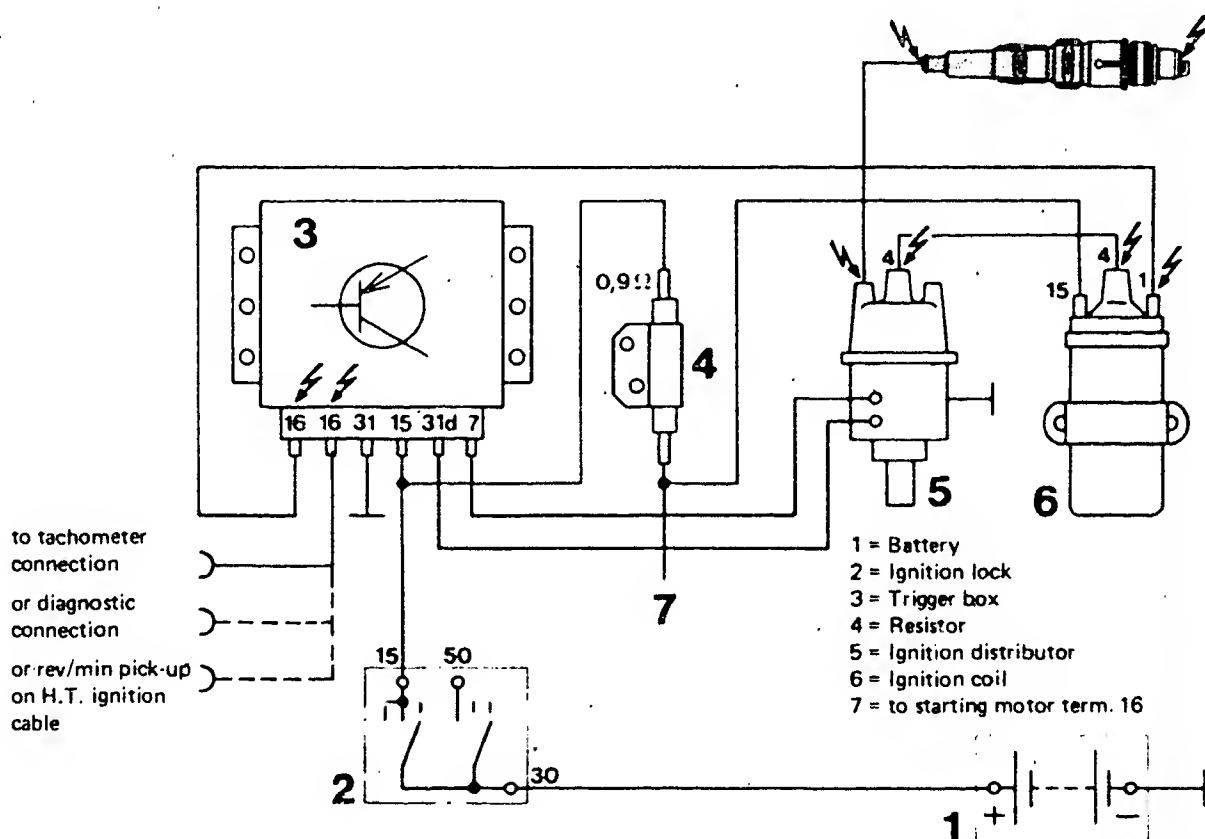
Terminal diagram

Below is a typical terminal diagram of a semi-conductor ignition system, the danger points are marked with red high-voltage arrows. We would point out that all semi-conductor ignition systems, even the older ones, are to be regarded as dangerous in the sense as defined by this bulletin.

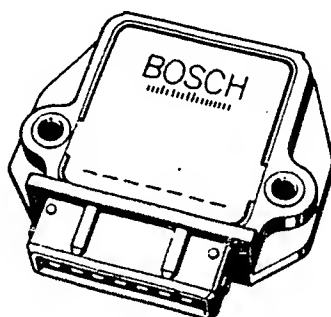
Fig. 1

Apart from the well-known TCI trigger boxes 0 227 100 0.., trigger boxes of hybrid construction have been fitted as standard since 9.78 (Fig. 1).

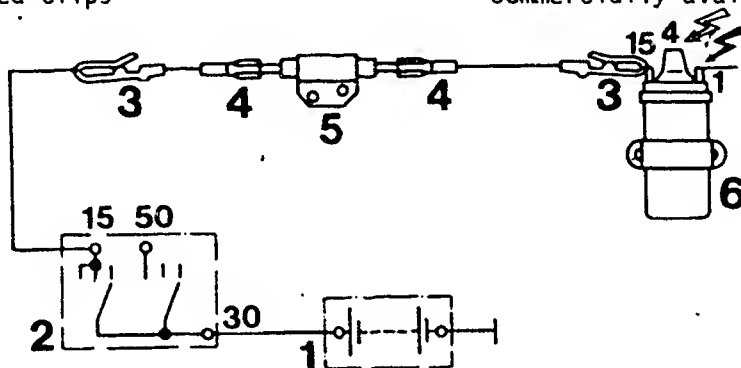
In comparison with conventional ignition systems, transistorized ignition systems with current limitation have different primary voltage characteristics. During the dwell period the voltage at terminal 1 of the ignition coil may assume values from 1.5 V to battery voltage (or greater). This may lead to an incorrect display of rotational speed and dwell angle when testing the ignition system. However, there is no functional defect in the ignition system, and, for this reason, the trigger box must not be replaced. Incorrect displays may occur with the testers listed below:

Connect a ballast resistor of 0.9 or 1.0 Ohm (see Fig.) in series in the line to term. 15 of the ignition coil (take care not to cause a short circuit). After the rotational-speed measurement, the ballast resistor must be removed (otherwise starting difficulties and misfiring). Connect tester as per operating instructions.
